AFRPL-TR-67-248

RESEARCH ON INHIBITED  $N_2O_4$

Fourth Quarterly Report

Rocketdyne  
A Division of North American Rockwell Corporation  
Canoga Park, California

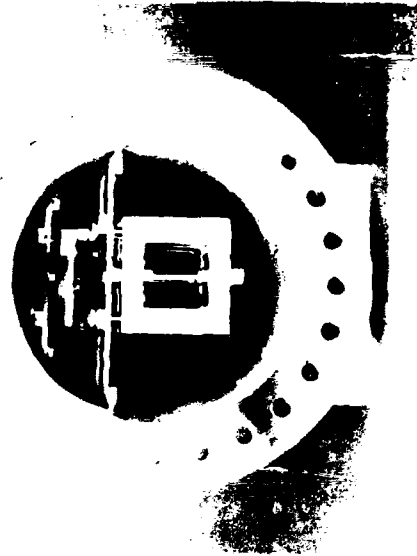
Figure 4. Loading and Supporting of Stress Frames in Tanks

The loaded frames were cleaned in acetone and loaded into racks in groups of three, as shown in Fig. 4A. Two racks were loaded into each tank. These racks were positioned in the tanks at different heights supported on rails as shown in Fig. 4B. The volume of liquid to be

added was calculated to provide for complete immersion of one set of three and to position the liquid-gas interface in the middle of the specimens in the other set. After positioning the frames in the tank, the gasket was inserted and the bolts tightened uniformly to 30 lb-ft torque.
